Evaluation Report No. E3178A
Printed: January, 1979
Tested at: Humboldt
ISSN 0383-3445

# **Evaluation Report** 144

# **International Harvester 241 Bigroll Baler**

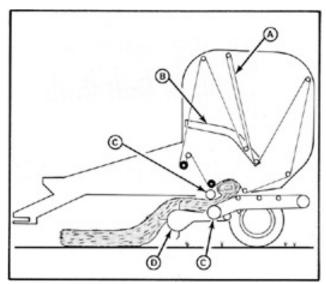
FIGURE 1. International Harvester 241 Bigroll Baler: (A) Bale Forming Belts, (B) Tensioning Arm, (C) Compression Rollers, (D) Pickup.

The International Harvester Model 241 is a pull-type, power take-off driven baler with a cylindrical baling chamber and a floating drum pickup. The twine wrapping mechanism is manually actuated with an electric actuator available as an option.

Hay is fed to the baling chamber between two compression rollers. The upper roller is rubber covered while the surface of the lower roller is covered with the platform belt. The baling chamber consists of one 1524 mm wide platform belt on the bottom and nine 102 mm wide forming belts on top. Platform belt position is fixed while the forming belts are spring loaded to position themselves around the bale during formation.

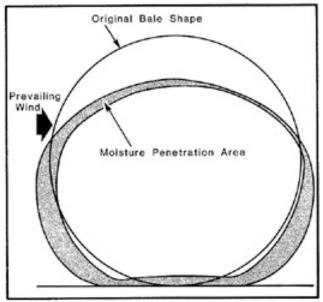
FIGURE 3. A Typical Bale After 100 Days of Weathering.

Bale Weathering: A common practice in the prairie provinces is to store round bales outside. FIGURE 3 shows the condition of a typical IH 241 hay bale (bromegrass and alfalfa mixture) after 100 days of weathering. The weathering period was the time between baling and freeze-up. Bales were situated in a well drained area with prevailing winds striking one side. Bales were exposed to about 75 mm of rain and average prairie wind conditions.

The condition of weathered bales was good. Moisture had penetrated to a maximum of 120 mm on the windward bale side. Since bales had retained 84% of their original height, they were easy to pick with round bale handlers.

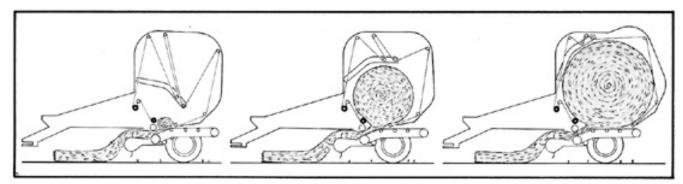
**FIGURE 6.** Stages of Bale Formation: (Left) Bale Core, (Centre) Half-Completed Bale, (Right) Completed Bale.

Forming a Bale: An inexperienced operator found some difficulty forming a bale with the IH 241 in light windrows. When starting a bale, it was important to weave the baler back and forth across the windrow, to feed hay evenly across the width of the baling chamber. The bale forming belts on the IH 241 did not turn until the bale core was large enough to press the belts against the drive rollers. If the bale core did not have a uniform diameter when the forming belts began to turn, the belts on the smaller end of the bale core sometimes slipped past the core end preventing bale formation. If this happened, the baler had to be stopped and the bale core ejected without twine. Once the bale core was properly formed, a slight weaving was needed during bale formation to maintain a uniform diameter.

In light windrows, the bale core sometimes went out-of-round. The out-of-round core contacted the forming belts drive roller preventing further bale formation. By opening the rear gate slightly and re-engaging the power take-off, the bale core could usually be wrapped with twine before ejecting. When this procedure did not work, the bale core had to be ejected without twine. Modifications to improve operation in light crops is recom-

FIGURE 6 shows the position of the forming belts during bale formation.
